TOSHIBA Leading Innovation >>>

Technical HandBook

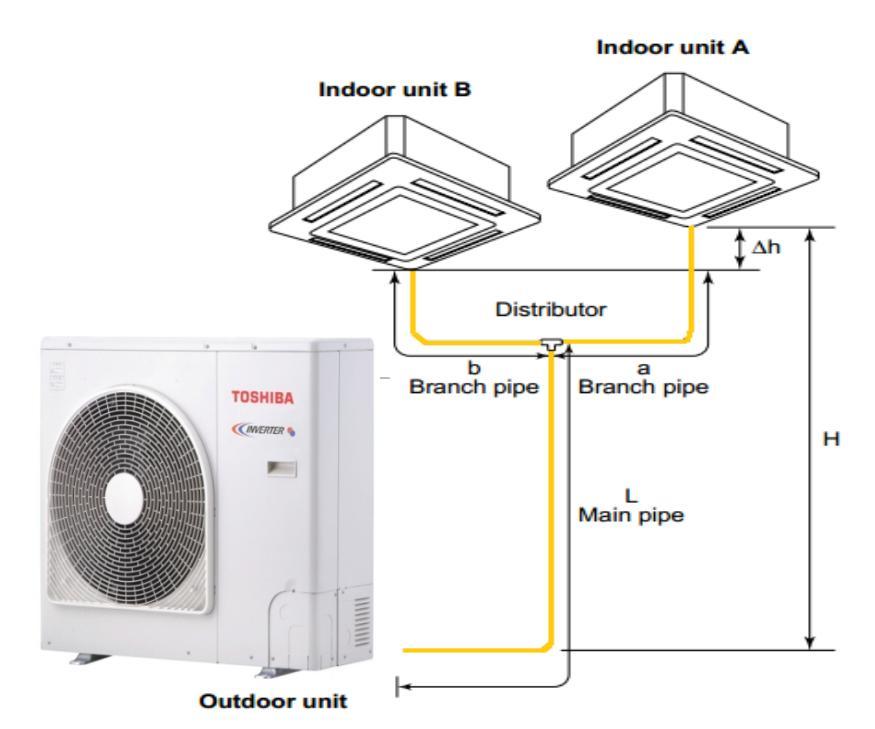
Pipe Specifications

Example 1 using SM2804AT8-E							
Total pipe length Branch pipe length	L - 28 x 0 a + b x ß	38 - 28 12 + 10 - 4	=10 x 0.080= =18 x 0.040= Add Amount	0.80 + <u>0.72</u> 1.52 kg

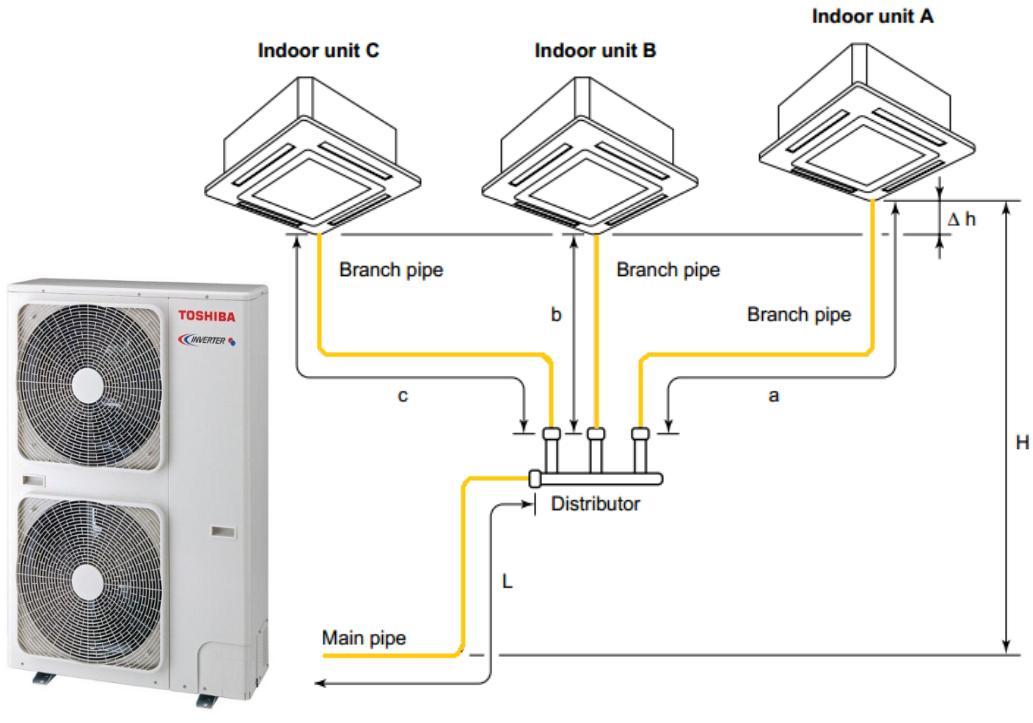
Pipe Specifications

Example 1 above using SM2804AT8-E						
Total pipe length Branch pipe length	L - 28 x C 38 - 18 a + b + c x B 12+10+ 12- 6	=20 x 0.080= =28 x 0.040= Add Amount	0.80 + <u>1.12</u> 1.92 kg

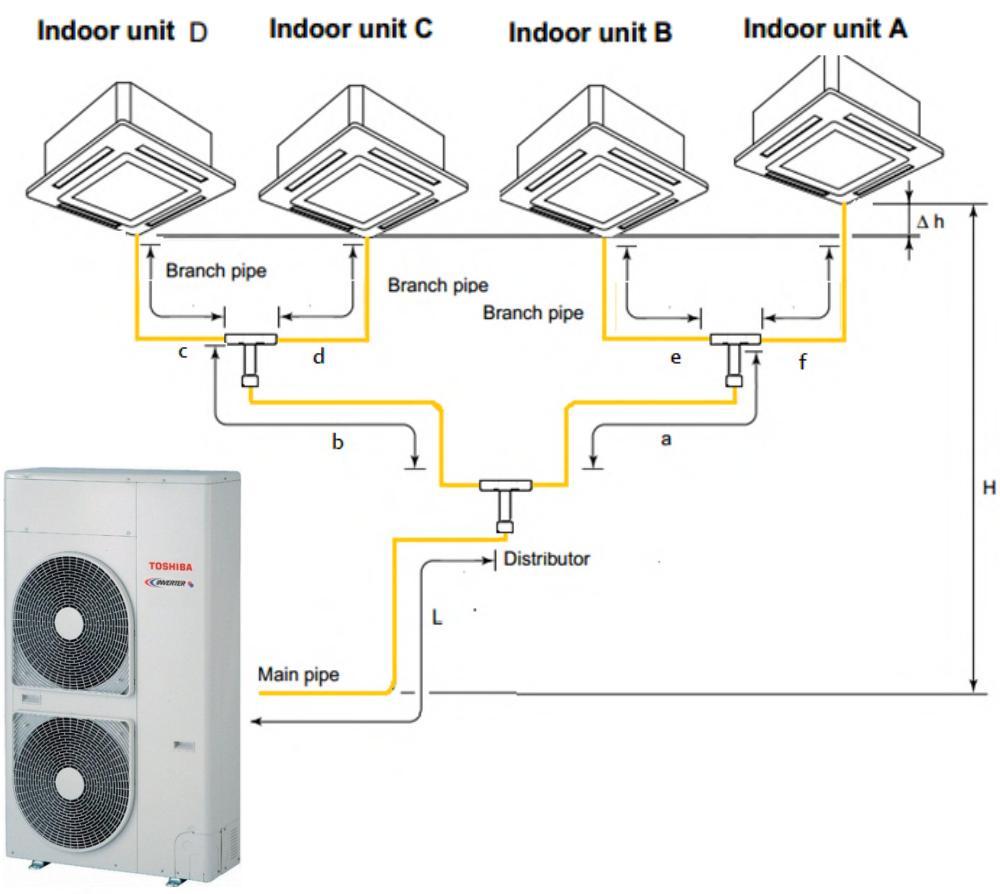
Pipe Specifications

Example 1 Installed length main pipe L to distributor=20m Installed length branch b=10m Installed length branch c=5m Installed length branch d=5m Installed length branch a=10m Installed length branch e=5m Installed length branch f=5m	Example 1 using SM2 Total pipe length Branch pipe length Branch pipe length	804AT8-E L - 28 x 0 . a + b - 4 x β c + d + e + f x γ	20 - 28 10+10- 4 5+5+5+5	=-8 x 0.080= =16 x 0.040= =20 x 0.040= Add Amount	-0.64 + 0.64 + <u>0.80</u> 0.80 kg
Installed length branch a=10m Installed length branch e=5m Installed length branch f=5m	Branch pipe length Branch pipe length	a + b - 4 x β c + d + e + f x γ	10+10- 4 5+5+5+5	=16 x 0.040= =20 x 0.040= Add Amount	0.64 + <u>0.80</u> 0.80 kg

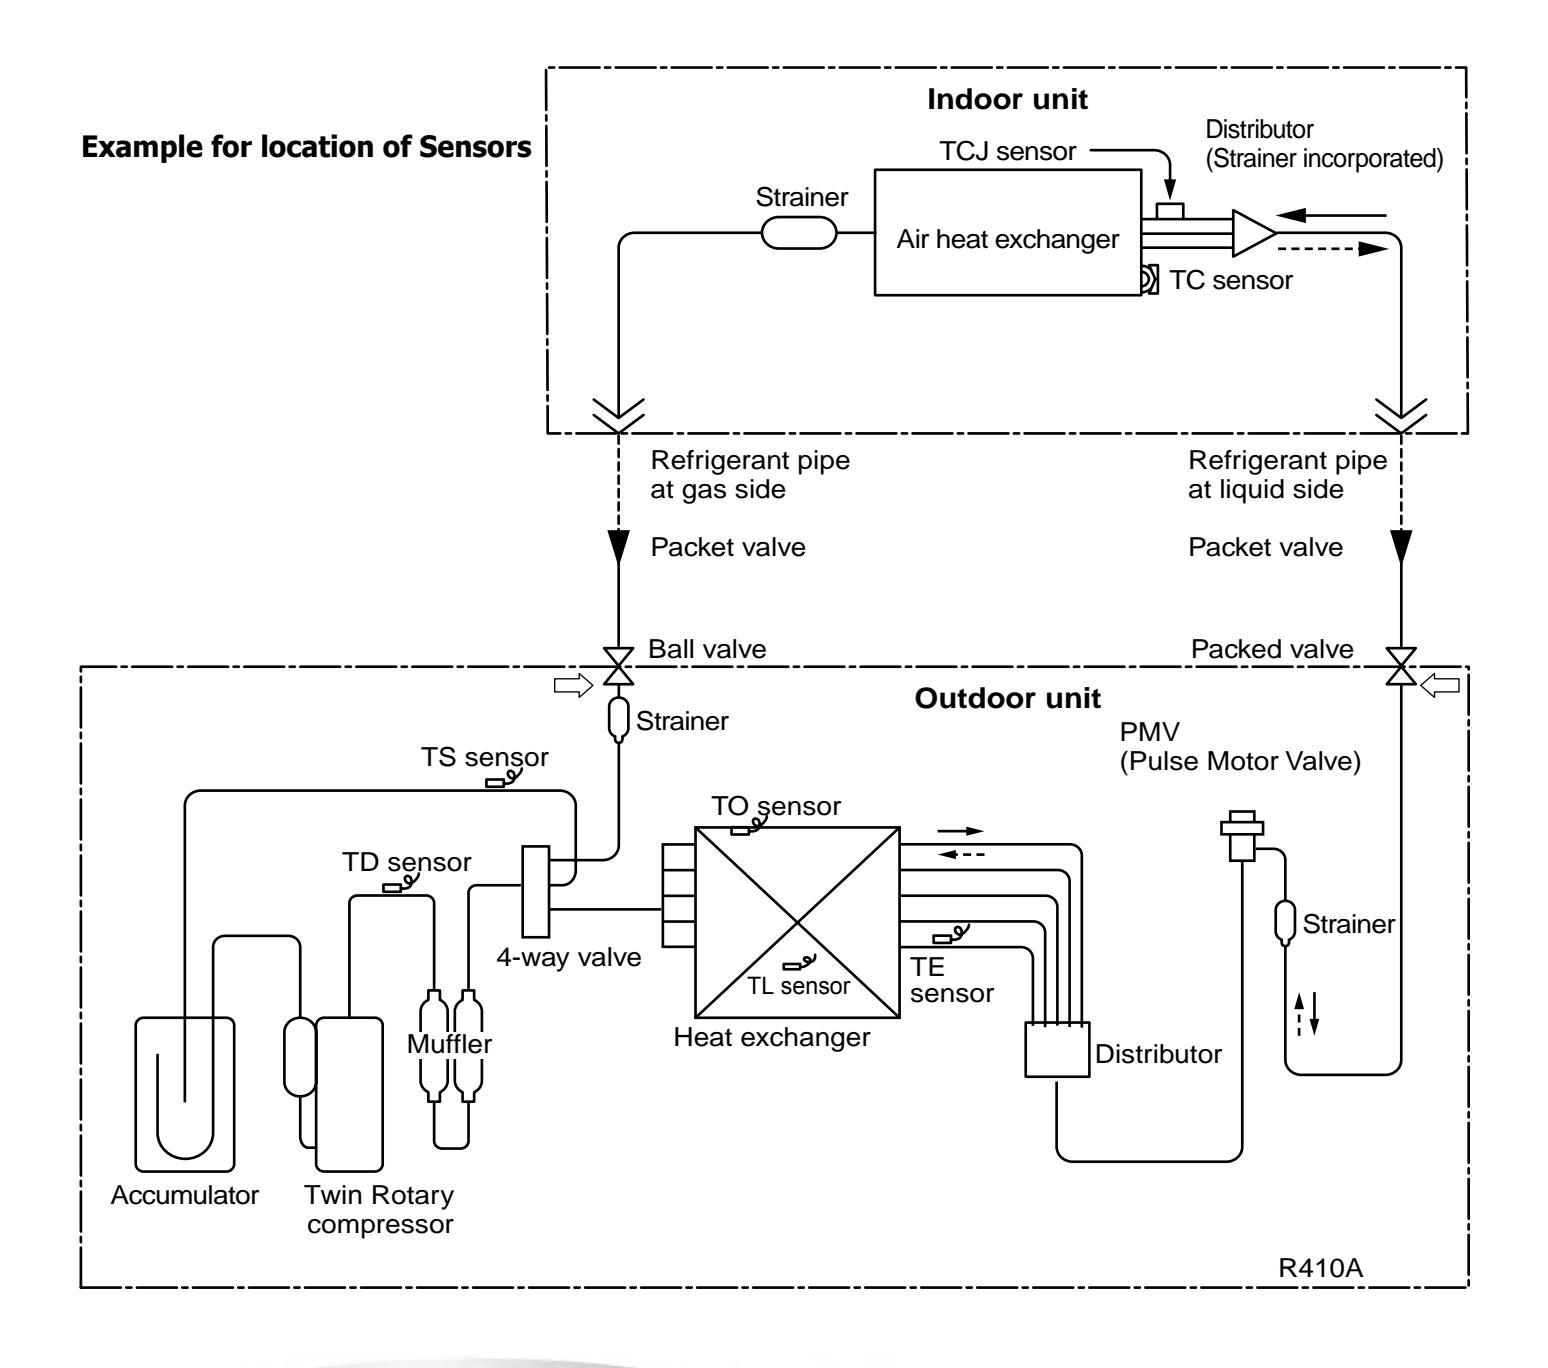
The Ta,Tc,TL and TE sensors all share the same resistance versus temperature characteristic. They differ however in electrical connections and sensing head style, therefore it is important to quote the full model type number when ordering any replacement sensors.

The Td sensor has a different resistance characteristic because its sensing range is that much higher than the others.

Sensor	-10	-5	0	5	10	15	20	25	30	35	40	45	50	55	60	100	٥C
Ta,Tc,TL,TE To, Ts	60.3	45.3	34.5	26.4	20.5	16	12.5	10	8	6.5	5.3	4.3	3.6	2.9	2.4	-	KΩ
Td, Tk	-	-	-	-	103	80.5	63	50	-	-	-	-	17.9	-	-	3.4	kΩ

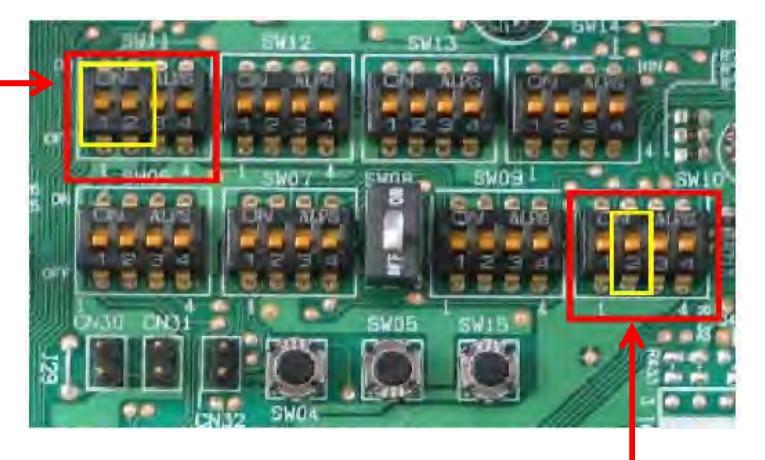
Outdoor Fan High Static Pressure Setup

This function is used when connecting a duct to the discharge outlet of an outdoor unit. To setup turn ON the DIP switch [SW10, Bit 2] provided on the interface P.C. board of the outdoor unit. This function must be enabled with every discharge duct connected outdoor unit for both of the header and follower units. It is necessary to increase the speed of the propeller fan units on the outdoor fan to allow the installation of a duct with a maximum external static pressure not greater than specified in the table below. If a discharge duct with a resistance greater than 15 Pa (1.5 mmAq) is to be used, enable this function. The maximum external static pressures of base units are shown below: -

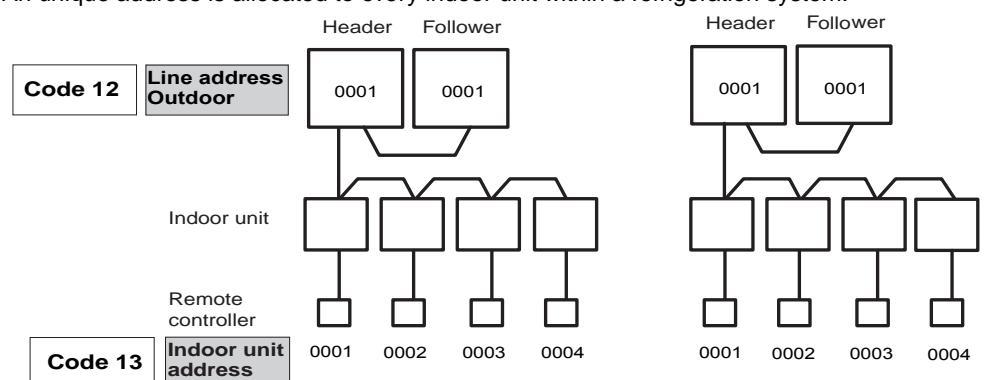
"Indoor unit address" This enables the outdoor unit to recognize each individual indoor unit. An unique address is allocated to every indoor unit within a refrigeration system.

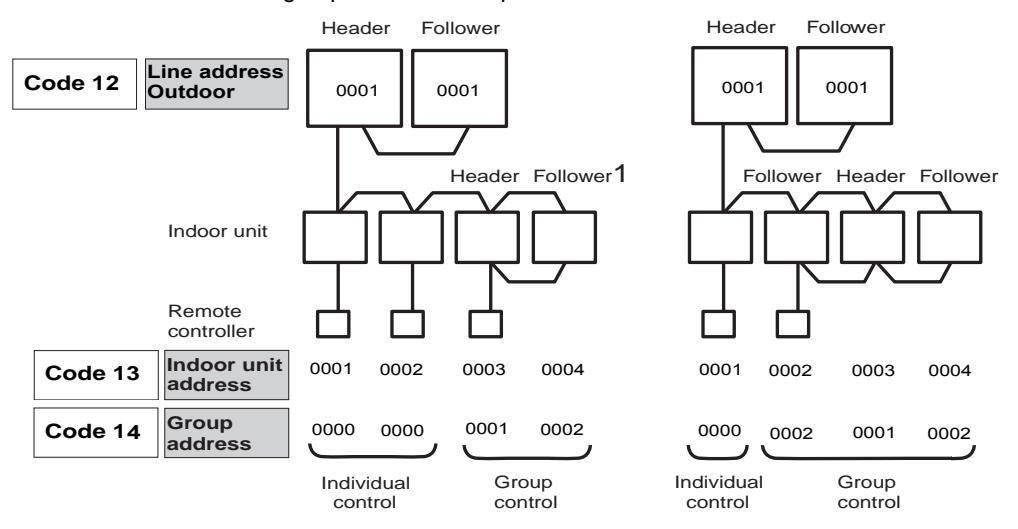
Group address (VRF) in case of DI/SDI, please refer to Address setup procedure (when using DI/SDI only or using DI/SDI and VRF) page 75 <u>"Group address"</u> This is the address that recognizes the group control and determines the header indoor unit and follower indoor unit. Group address and the header indoor unit is decided automatically when the automatic address setting is performed. (Which indoor unit becomes the header unit is indefinite when automatic address setting is performed.)

Indoor unit of individual control : Group address = 0 Header indoor unit of group control : Group address = 1 Follower indoor unit of group control : Group address = 2

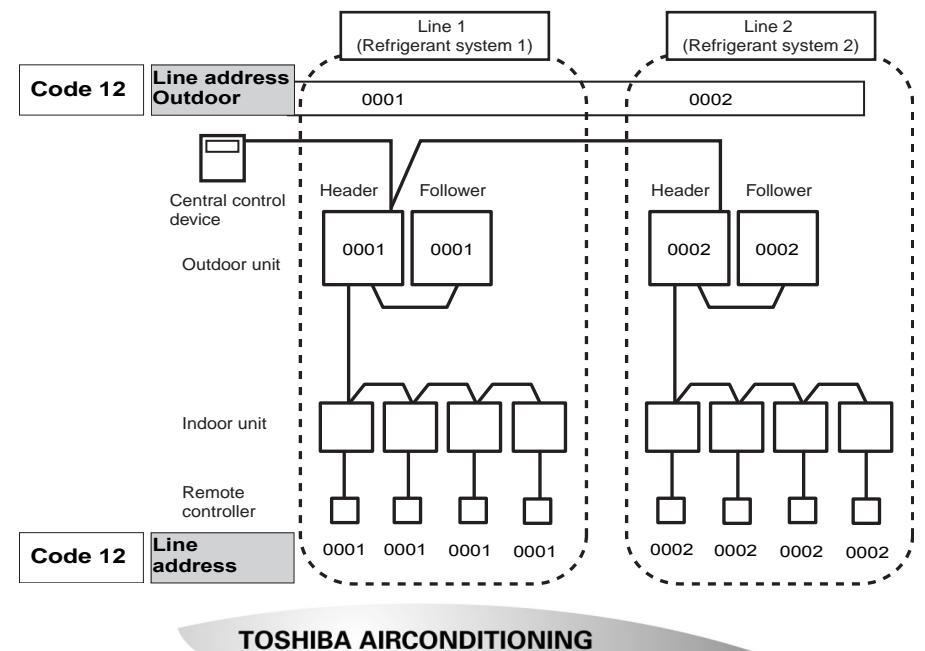
Line address (System address)

"Line address" is the address in which the line (refrigerant system) indoor units are connected.

This line address is set by a switch setting on the interface P.C. board on the header outdoor unit Factory setting : Line address is '1'.

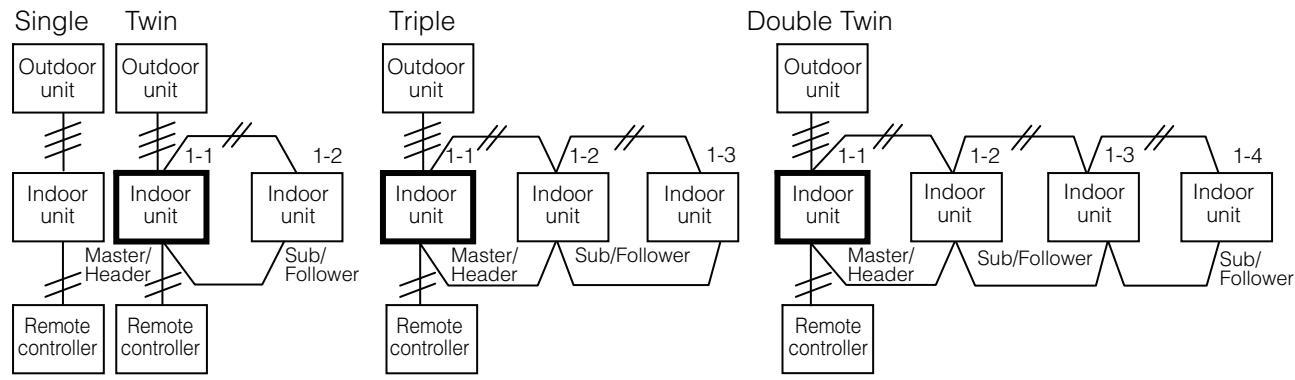
The basic DI/SDI connection configuration of each type of model is shown below.

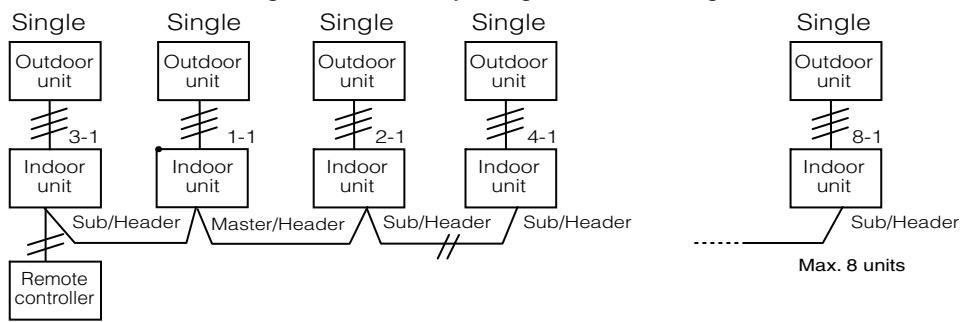
Group configuration (single only)

In this case, address setting can be made by using auto addressing.

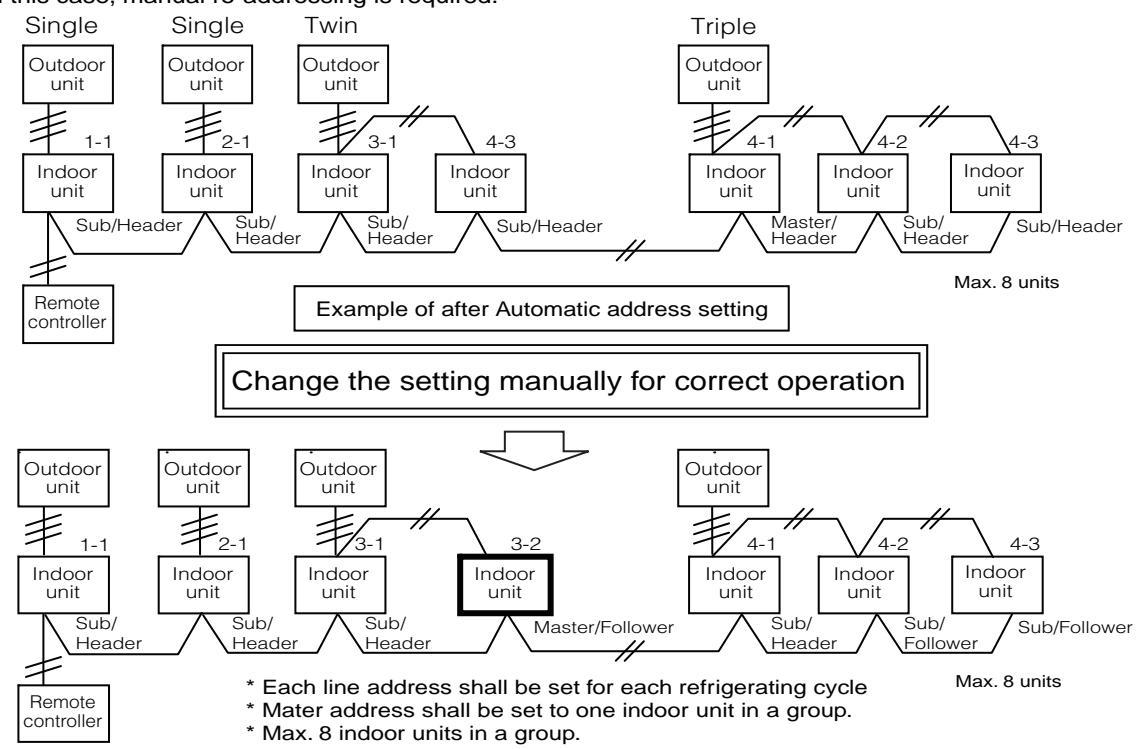
Multiple Group configuration (combination of single/twin/triple) In this case, manual re-addressing is required.

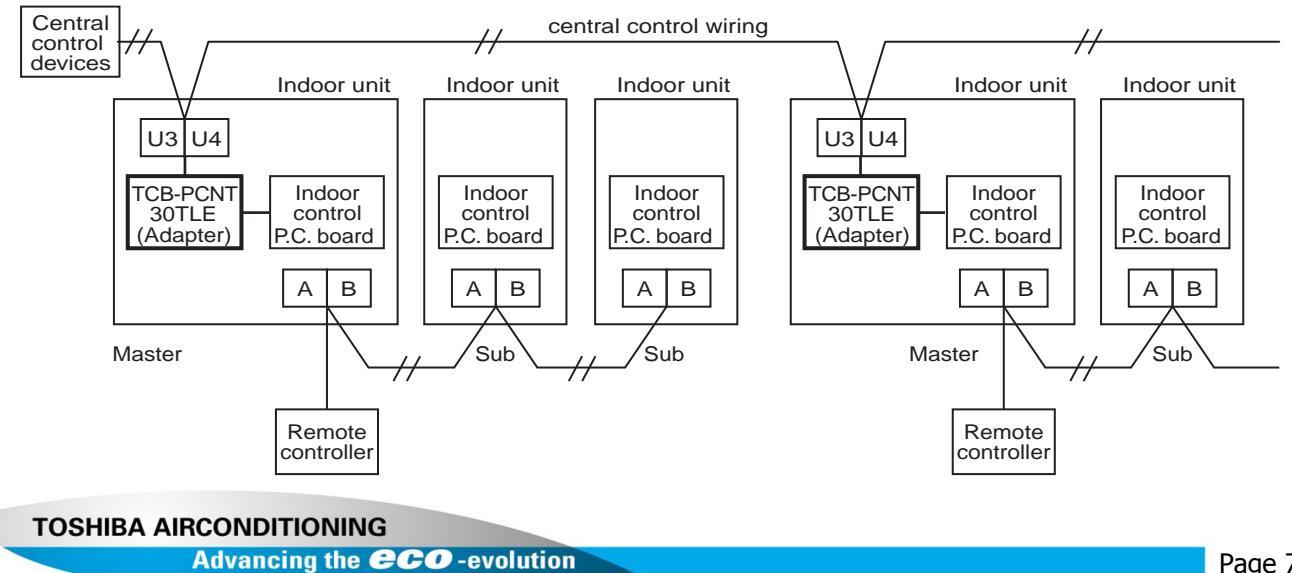
Connection and Address re-setup example for central control "1:1Model" Connection Interface TCB-PCNT30TLE2

When controlling the super-digital inverter and the digital inverter, the adaptor named "1:1 model" connection interface (TCB-PCNT30TLE2) is necessary.

Attach an adaptor per 1 group in the group control operation (including individual control). Connect the adaptor to the Master indoor unit in the group control.

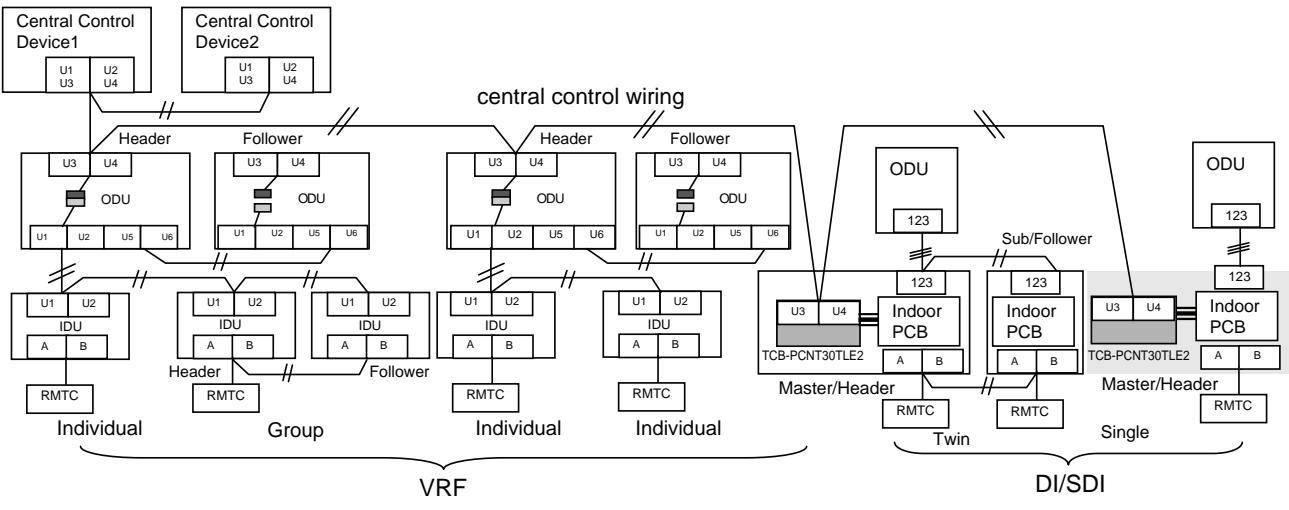
A central control connection example of a system where both VRF and DI/SDI are used is shown below. The VRF and DI/SDI subsystems are connected through the central control wiring and to the central control devices.

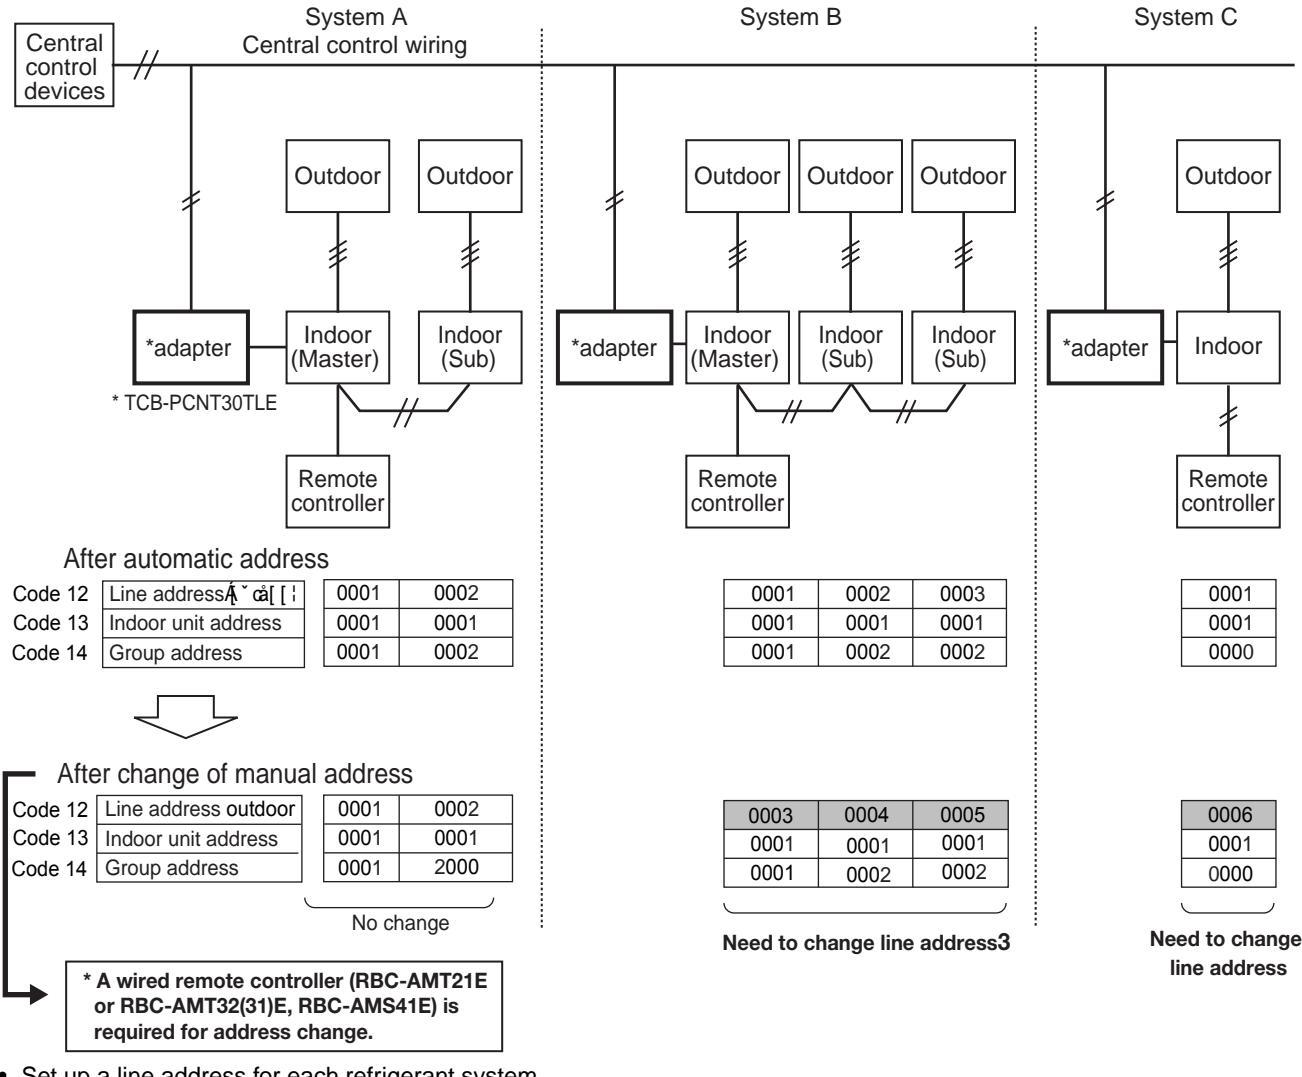
After automatic address setup, it is necessary to change the line address from the wired remote controller for each system. **Reason**: After automatic address setup, all of the line addresses will become "1" except in a group control and then a duplicated address error "E08" will be outputted.
